HWBI HOME INSPECTIONS
Certified Inspector

Inspection Date: May 4, 2020
Time: 2:00 P.M.

Address: xxxxxx xxxxxx,
Sacramento, CA 95826
Home Type: Single Family
Prepared for: Jerry Mills
Real Estate Agent: Joe Smith
Occupancy: Occupied
Weather: Sunny 86
Foundation: Slab on grade
Pool: Yes

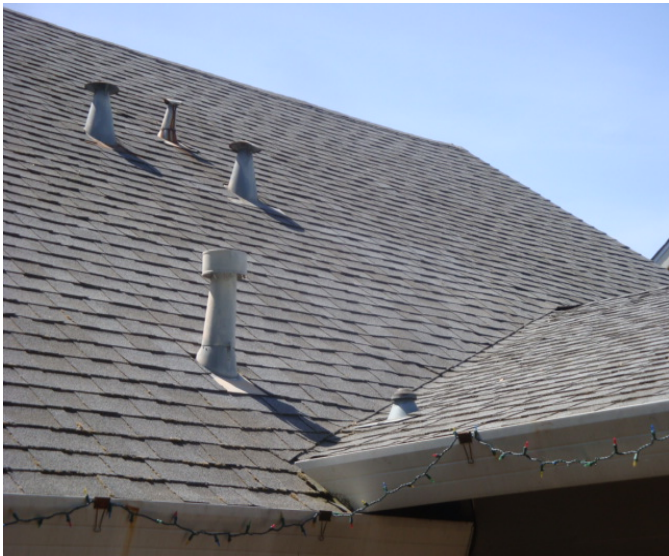
1. ROOF Condition:

Materials: Asphalt Shingles, 9 years old roof and appears to be in good serviceable condition. Flashing, Vent caps are also in good serviceable condition, No discrepancies. Down spouts and gutters in good serviceable condition.

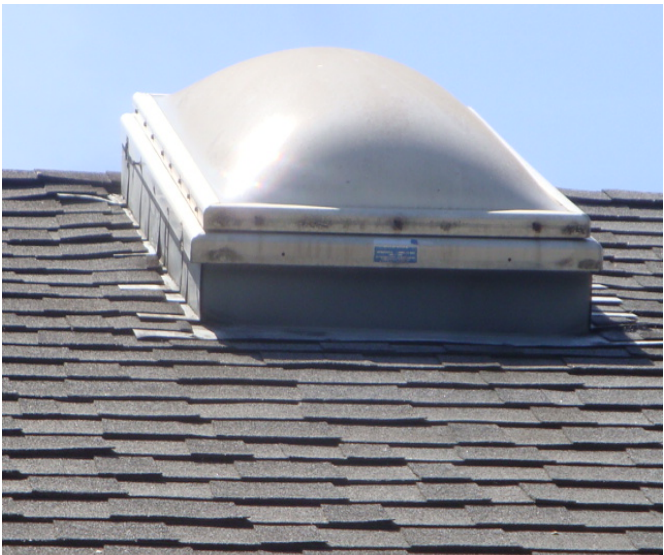
Skylight in good serviceable condition. Plastic glass could be cleaned.

Page 4. Roof: Plastic Glass on Skylight could be cleaned

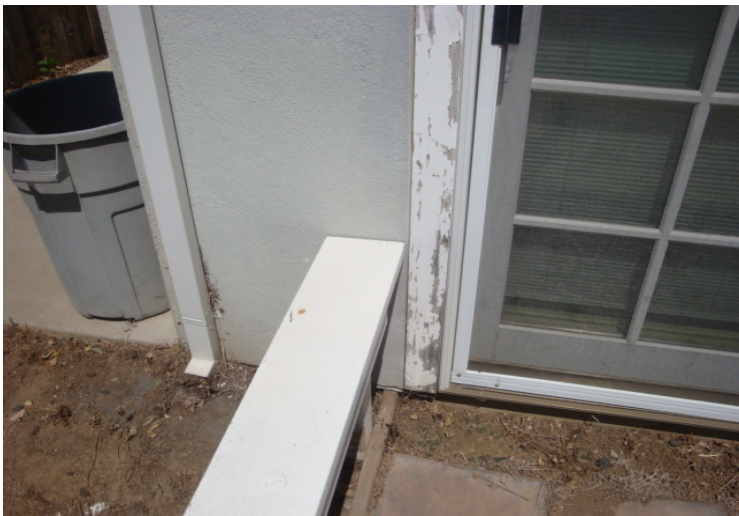
1. EXTERIOR Condition:

Exterior: front part of the house is wood siding and the Back and side walls are Stucco is in good serviceable condition. Trim around sliding door, bedroom and kitchen windows trim is peeling, needs scraping, caulking, sealing and paint.

Page 5. Exterior: 1. Trim needs scraping, painting and Caulking. 2. Cosmetic repair: holes from cable and TV installation. Needs patch and paint.

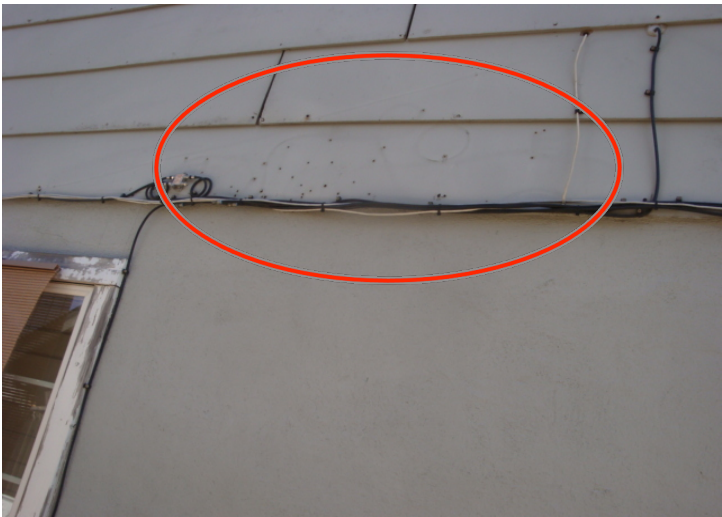
Exterior: Cosmetic repair, holes from cable and TV installation, patch and paint.

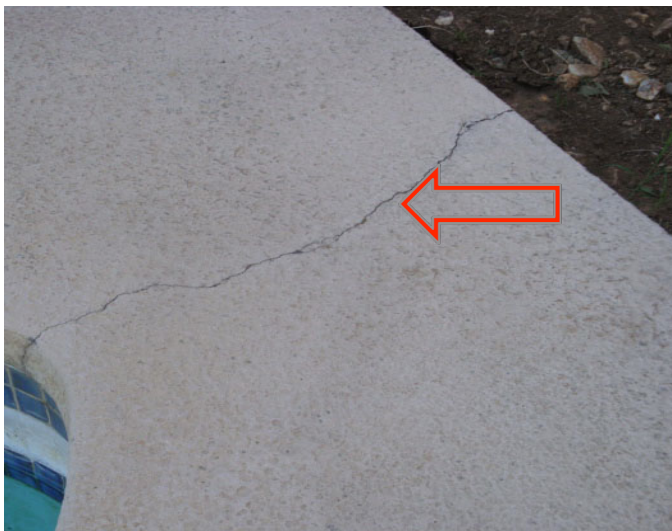
1. Basement, Foundations, Crawlspcace, Structure:

Inspected the porches, patios all in good serviceable condition. Foundation: Slab on grade. Grading of the property very good. No signs of house movement or walls cracked serviceable condition. Pool deck walk way has one crack on back end, Recommend Repair, seal or replace by Licensed Contractor.

Page 6. Foundation etc: 1. Crack in walkway around the pool. 2. Cracks in driveway. Recommend have checked by a license contractor.

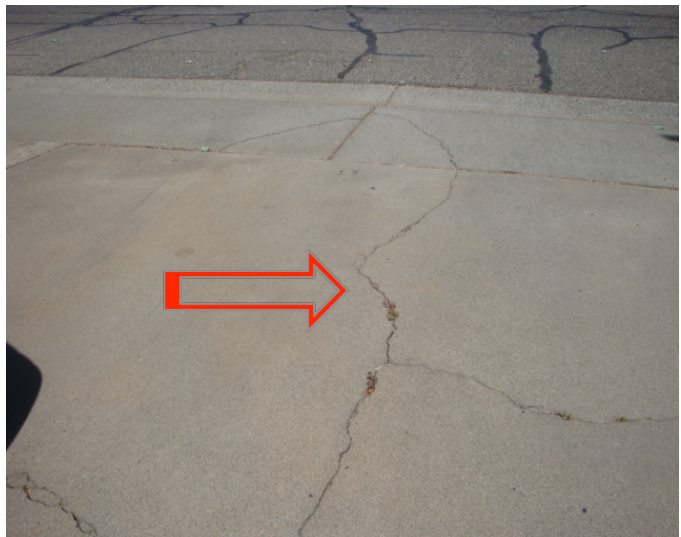
2. Basement, Foundations, Crawlspcace, Structure:

Several Cracks in drive way, possible tree roots, recommend having it checked by a Licensed Contractor.

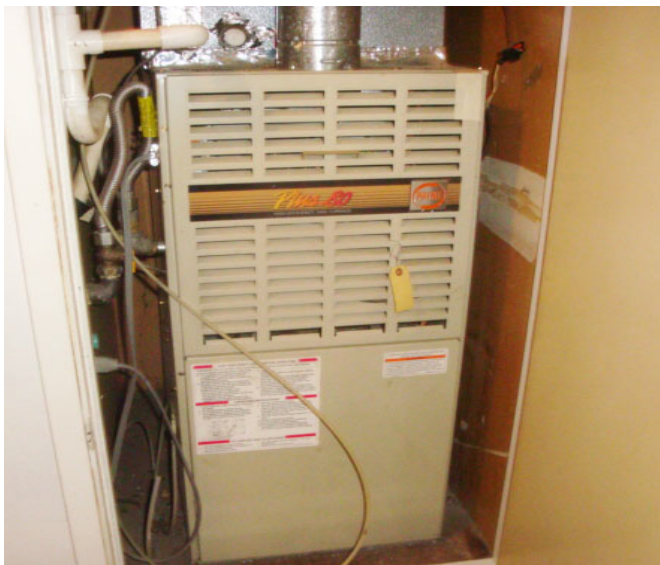
1. HEATING Condition:

Heating system is working using normal operating controls. The unit has not been serviced for 2 years. Recommend servicing both the A/C unit and the Heating Unit by a professional A/C certified Service.

Page 7. Heating: Has not been serviced for 2 years, Recommend get inspected as soon as possible by a certified AC inspector.

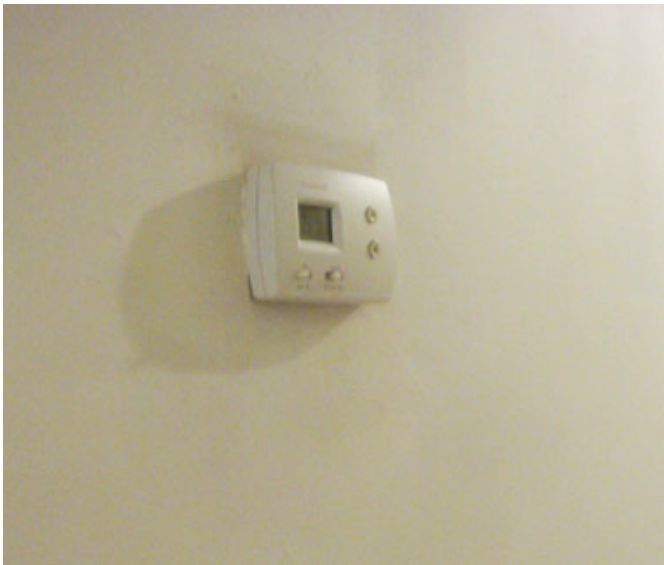
2. HEATING:

Thermostat was in good working condition at time of inspection. Mounted on the hallway wall.

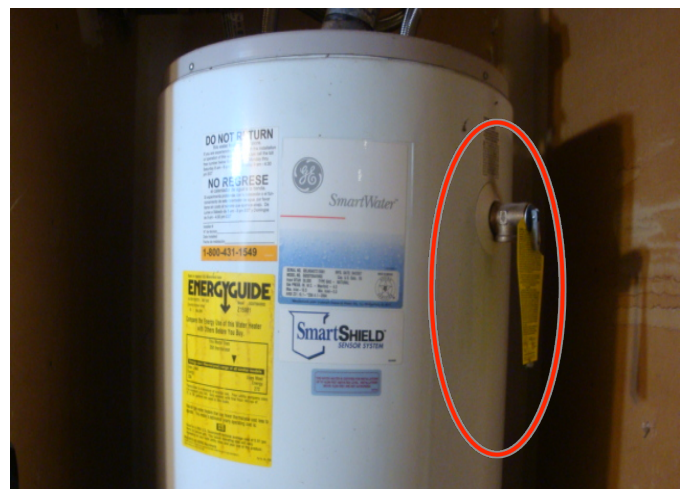
2. PLUMBING: Hot Water Heater

Hot water is a 50 Gallon Smart Shield Sensor System, sinks, tubs are in serviceable condition. Hot water TPR discharge pipe (drain Line) is not present. Recommend a certified plumber to inspect and install.

Page 9. Plumbing: Drip in bathroom sink and TPR discharge pipe needs repair/replace. Recommend get inspected repaired/installed by a license Plumber.

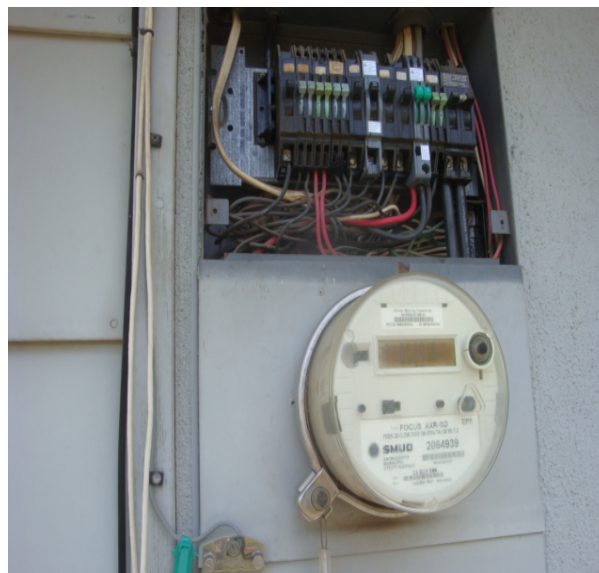
2. ELECTRICAL:

Electrical wiring appears to be satisfactory at the time of inspection. Switches, light fixtures and receptacles were found to be in good serviceable condition.

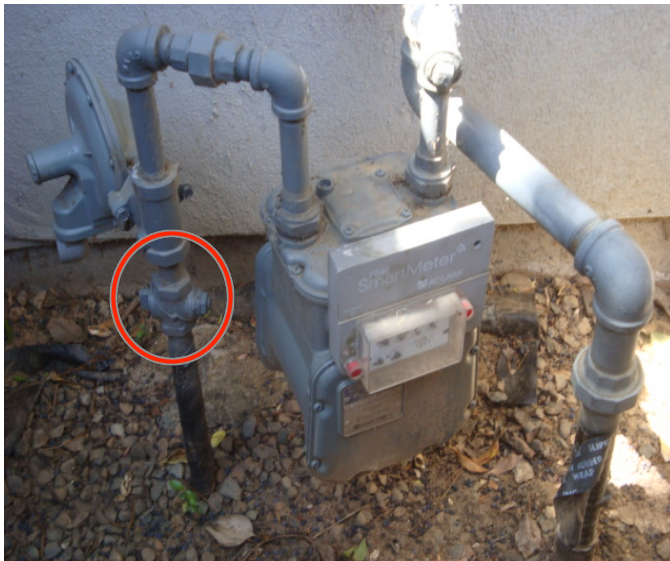
Gas Shut off valve on the left side of house, good condition.

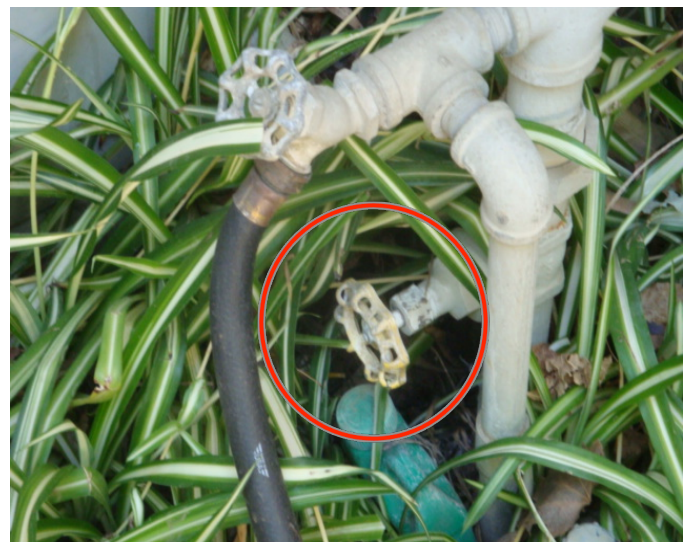
Water shut off valve in front of house by walkway. Could use shrubs cut back.

Page 11. Water Valve: Shrubs could be trimmed away from Water main valve.

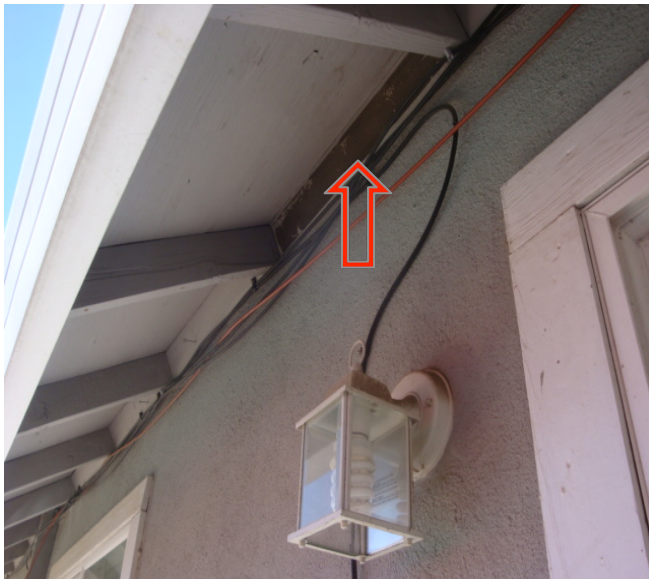
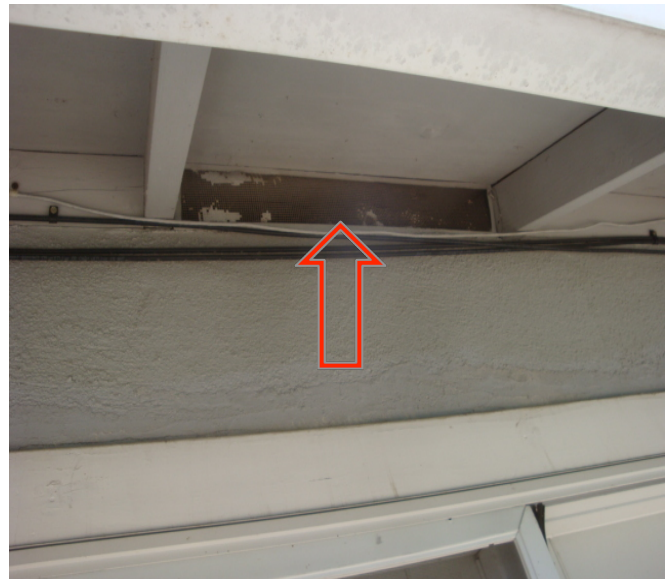
1. ATTIC, INSULATION & VENTILATION:

Did not have access to Attic, clothes and boxes blocking access door. Vents in the rear of the house are filled with debris and spots of paint. Recommend clean and remove paint from vent.

Page 13. Ventilation: Vents in front and back of house are filled with debris and spots of paint. They need to be cleaned for proper ventilation.

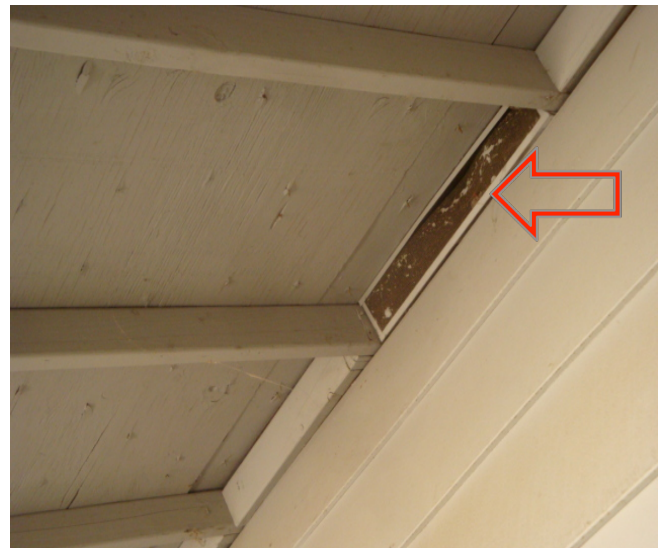
2. ATTIC, INSULATION & VENTILATION:

Vent in the front of the house are filled with debris and spots of paint. Recommend clean and remove paint from vent.

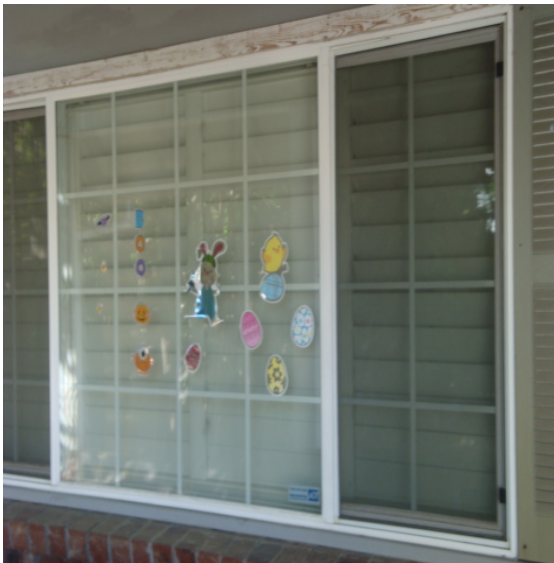
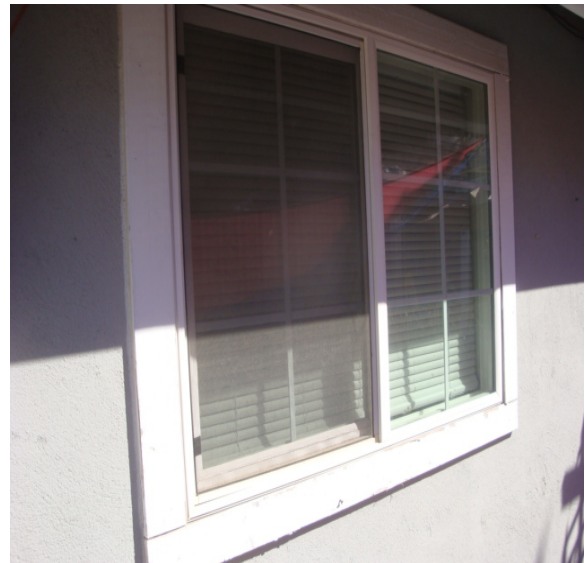
1. DOORS, WINDOWS & INTERIOR:

Windows are double pane, installed 10 Yrs ago. Paint around windows trim is peeling, needs scraping. Caulking / sealing and paint.

Page 14. Windows: Front and back window trim is peeling and need to be scraped, painted, sealed and caulked.

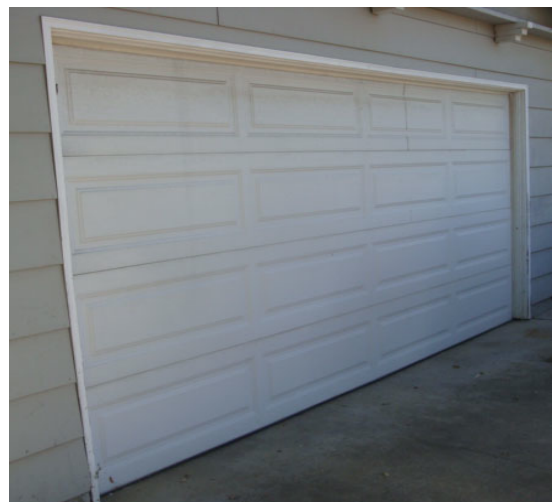
2. DOORS, WINDOWS & INTERIOR:

Doors, steps, landings and Garage door was inspected, garage door opener and photo safety sensors work and are in good serviceable condition.

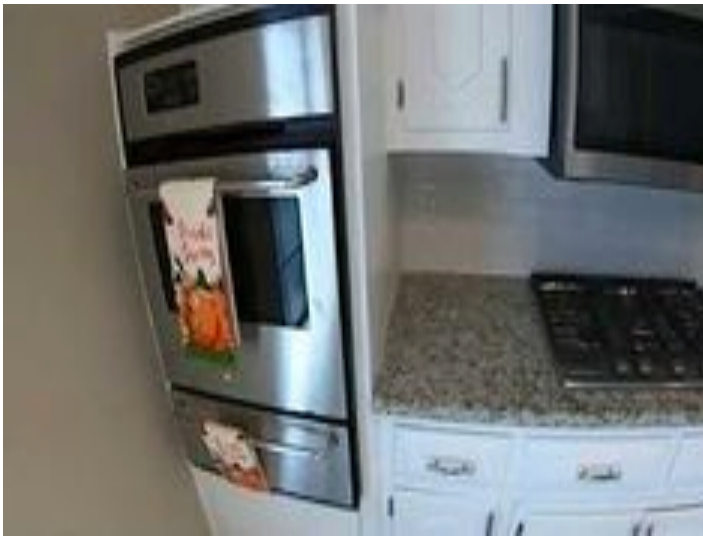
1. OPTIONAL SYSTEMS & COMPONENTS:

Kitchen Range cook top, Microwave , Disposal and microwave in good serviceable condition.
